Home Inspection Report

58 Bridge Road, Katonah, NY 10536

Inspection Date:
2/2/2010

Report Number:
Sample

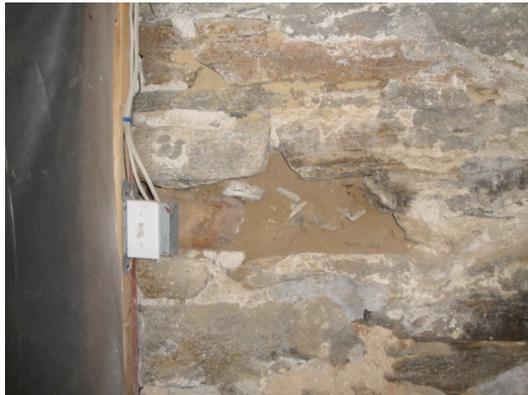
Foundation

- **Monitor:** Common minor settlement cracks were observed in the foundation walls. This implies that some structural movement of the building has occurred. Cracks of this type should be watched for any sign of additional movement. In the absence of any sign of ongoing movement, repair should not be necessary.
- **Repair:** Surface deterioration (spalling, crumbling material) was observed on foundation walls. This condition is common in many old homes and does not usually represent a serious structural concern unless there is substantial loss of material. In an effort to prevent long-term deterioration, it would be wise to consider parging (a concrete stucco-like coating) over deteriorated areas. Lot drainage

improvements and elimination of water or roof runoff splashing against foundation walls as outlined in the Exterior section of this report are also recommended.

Parging of the interior of the old foundation walls is desirable to improve appearance and avoid further foundation damage.

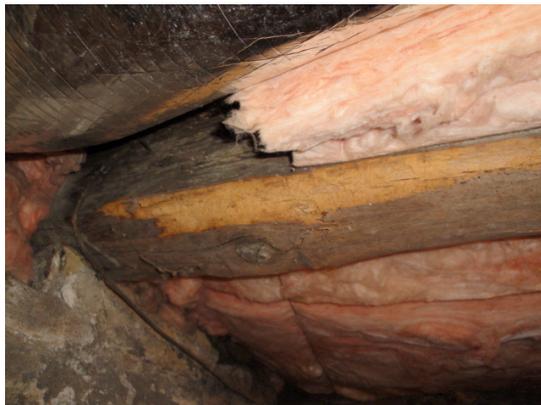
Wood Boring Insects

- **Monitor:** Evidence of termite damage was observed in the basement and there is risk of additional hidden damage since termites can do a substantial amount of damage. Any wood soil contact should be eliminated.

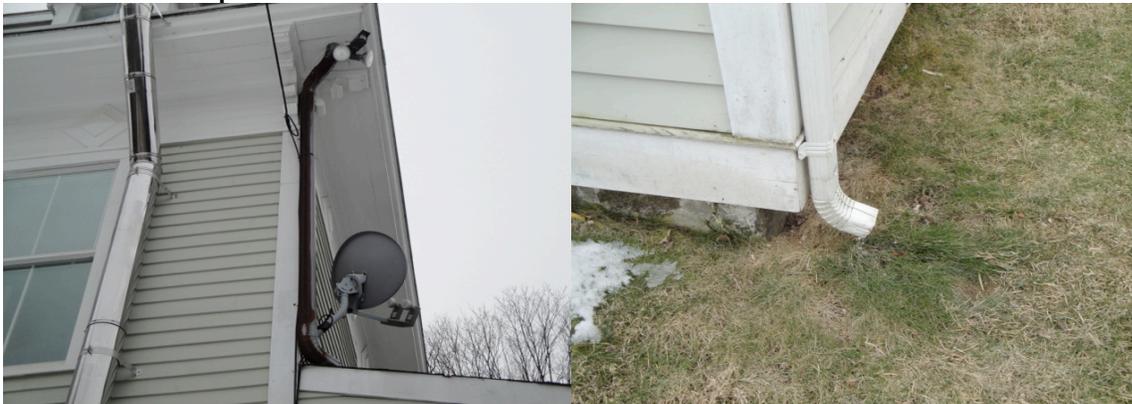
Gutters & Downspouts

- **Repair:** Leaks in the built-in gutters should be repaired.
- **Monitor:** The lower gutter does not appear to have sufficient slope to drain properly at the end of the porch. If they do not perform as intended, the slope should be adjusted to avoid spilling roof runoff around the building – a potential source of water entry or water damage.
- **Repair:** The old galvanized downspout in the rear of the home is rusting noticeably. Replacement should be anticipated over the next few years. In the interim, leaks that develop should be repaired.
- **Repair:** The downspout(s) should discharge water at least five (5) feet from the house. Storm water should be encouraged to flow away from the building at the point of discharge.

Covering the gutters with a protective mesh may help to avoid congestion with leaves and debris.

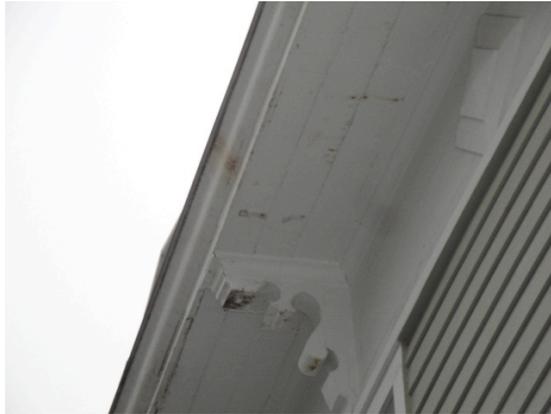
Exterior Eaves

- **Monitor:** Localized rot was observed under the built in gutter. This condition should be repaired when exterior painting or maintenance are planned.

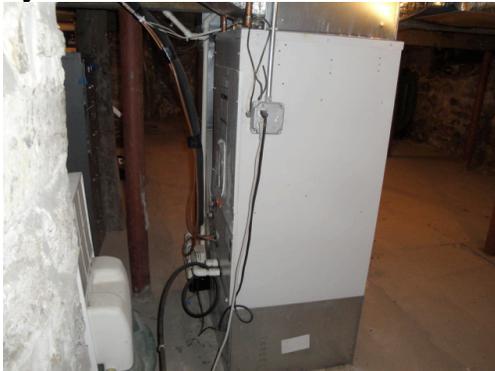
Hydro-Air

- **Monitor:** The heating system requires yearly servicing. This should assure safe, reliable heat.

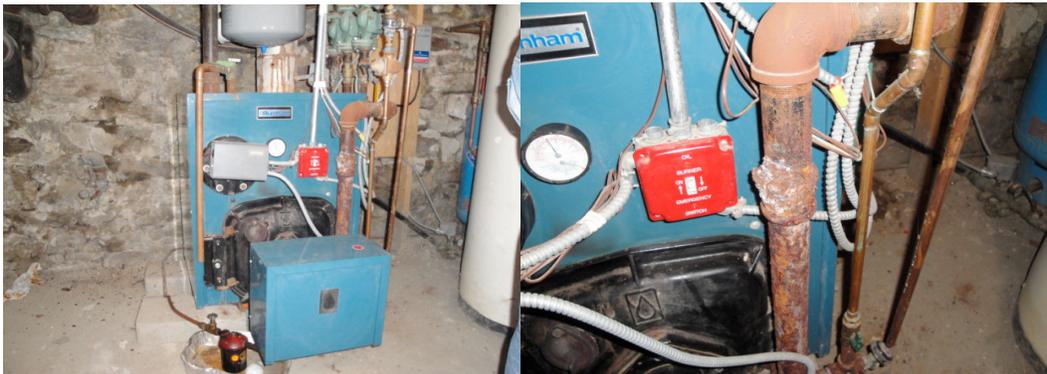
Boiler

- The boiler for this unit appears to be in working condition and within its expected life span. Actual equipment life will vary depending on quality of equipment and quality/frequency of service.
- **Repair:** Corrosion was observed around the exterior piping of the boiler. Repairs will be needed in order to avoid damage to the equipment or to the building caused by leaks.

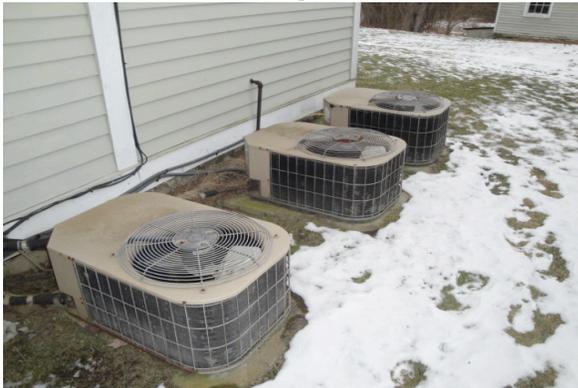
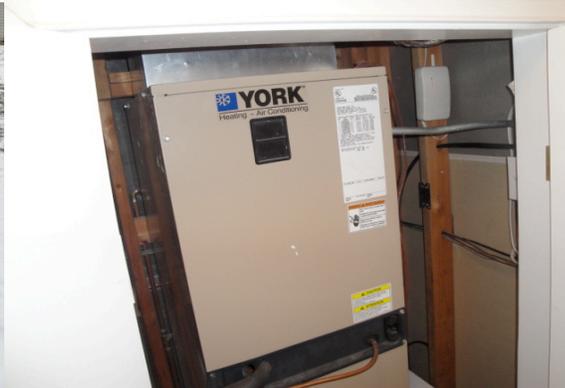
Central Air Conditioning

- **Improve:** The air conditioning system may require servicing before use.
- **Monitor:** There are three air handlers throughout the house. (*Three zones*) One handler in the basement, one handler on the second floor, and one on the third. Each unit has a filter, make sure these filters get replaced every few months.

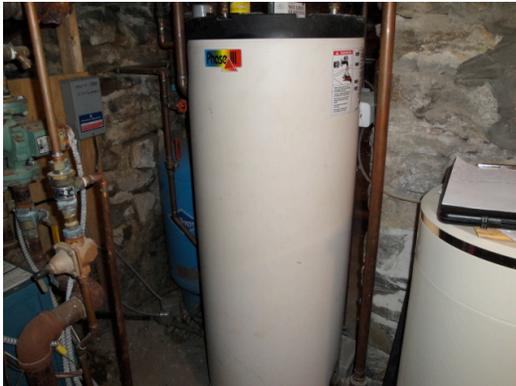
Water Heater

- **Monitor:** Water heaters have a typical life expectancy of 7 to 12 years (*For this indirect unit it is more like 20 Yr*). One cannot predict with certainty when replacement will become necessary.

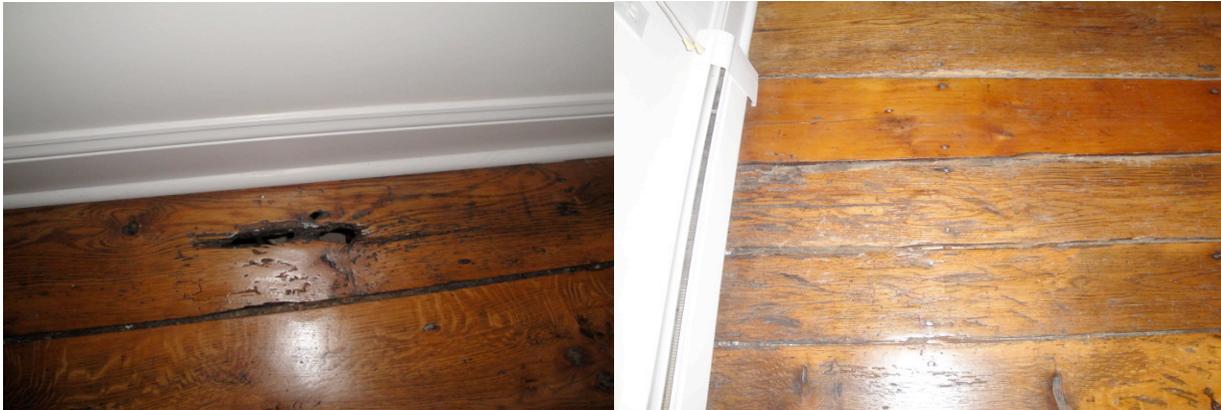
Floors

- **Monitor:** Movement of the floors is apparent. Refer also to the Structural Components section of this report.
- **Improve:** Large gaps in the older wood flooring should be filled.
