TrueView Home Inspections

Home Inspection Report

101 Main Street

Inspected On Tue, Jan 10, 2023 at 12:00 AM

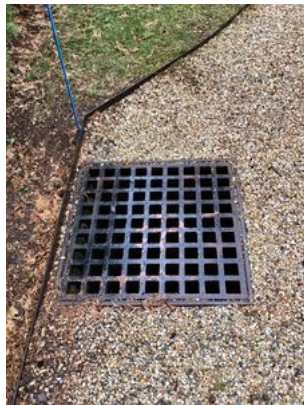
Comment 1

Keep exterior drains clear of debris.

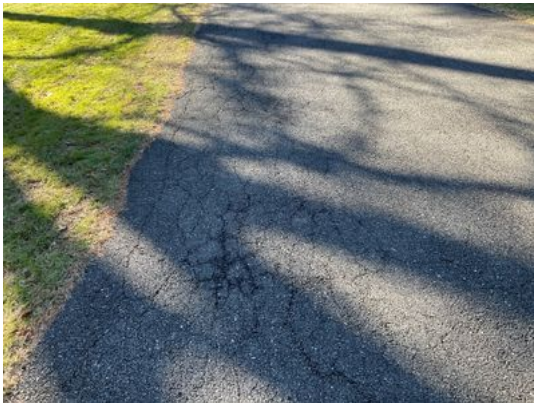
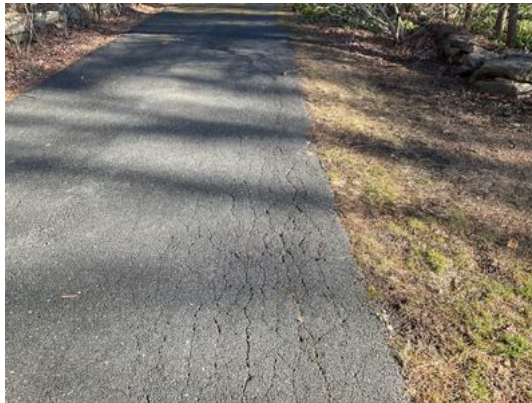
Comment 3

Cracking to the driveway surface was observed.

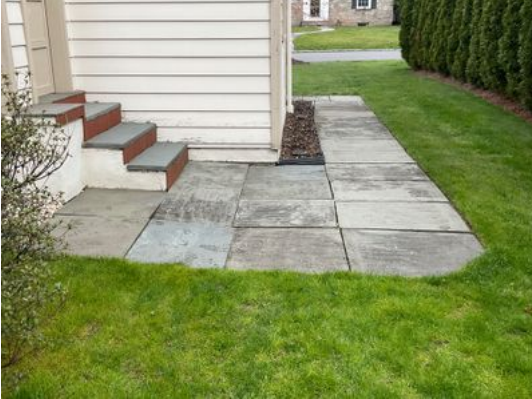
Comment 4

The walkway is in need of re-pointing repairs.

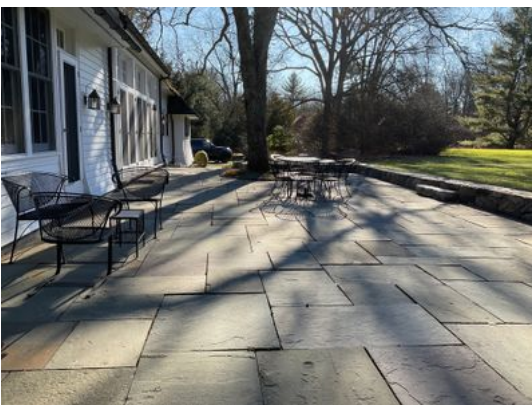
Comment 5

Evidence of heaving and settlement was observed to the stone patio. Leveling of the stones is needed.

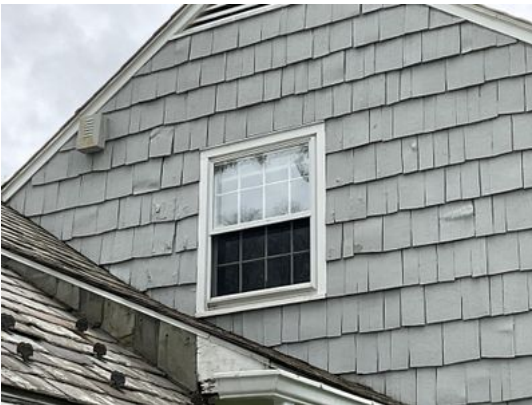
Comment 6

Peeling paint was observed at the siding.

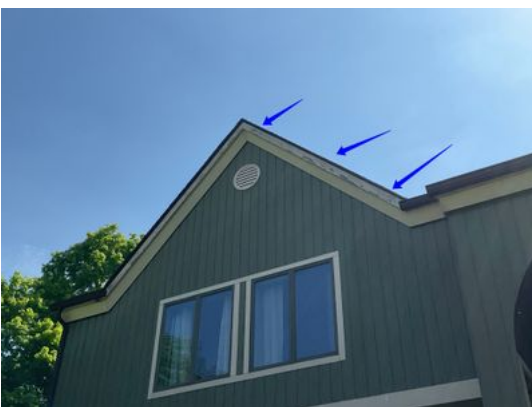
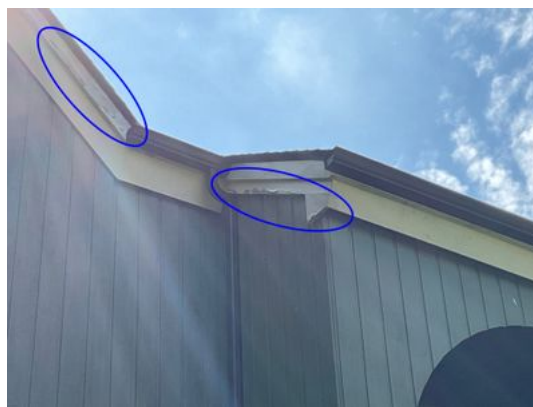
Comment 7

Soffit/Fascia/trim Painting Needed

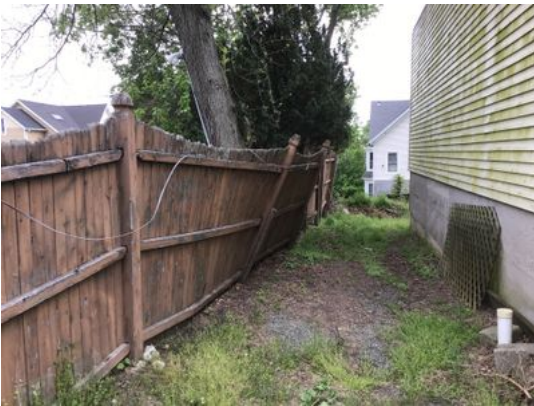
Comment 8

The fence is in Poor Condition and it requires repairs or replacement.

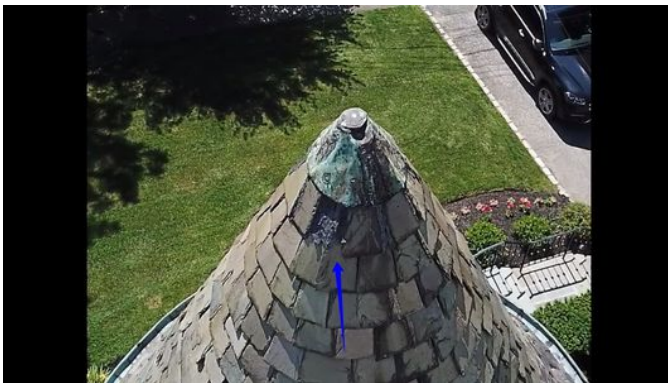
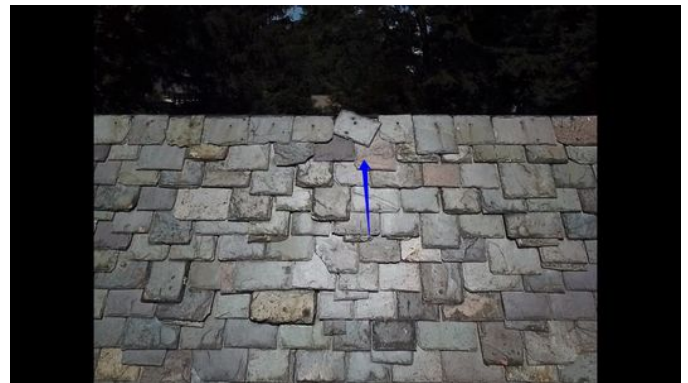
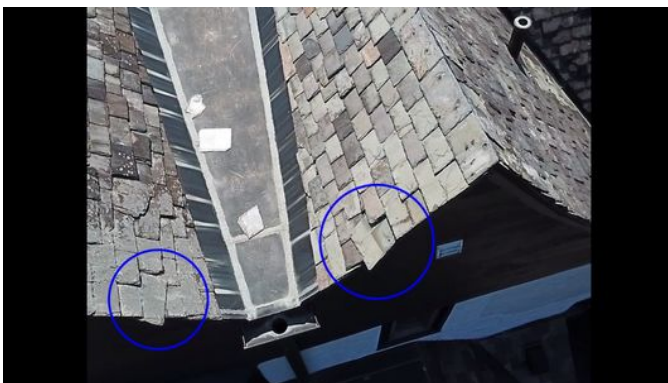
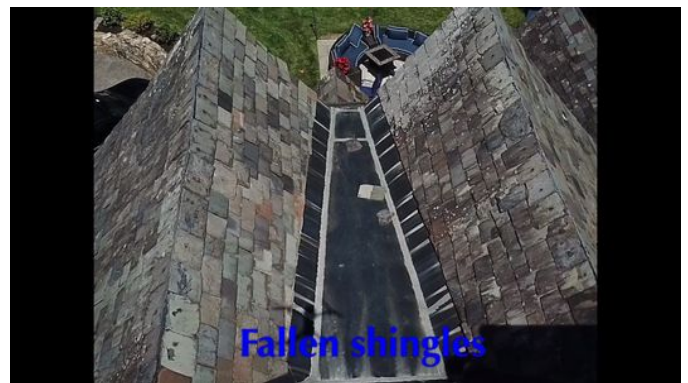
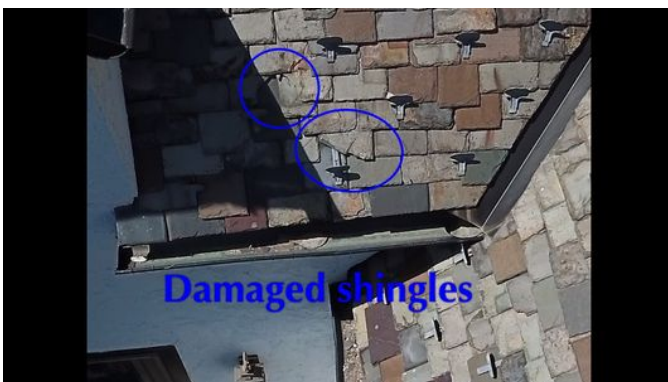
Comment 10

Repairs to the roofing are needed. Damaged or loose roofing materials should be repaired.

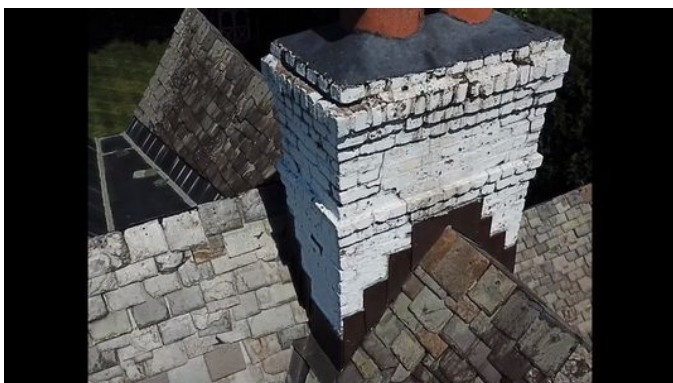
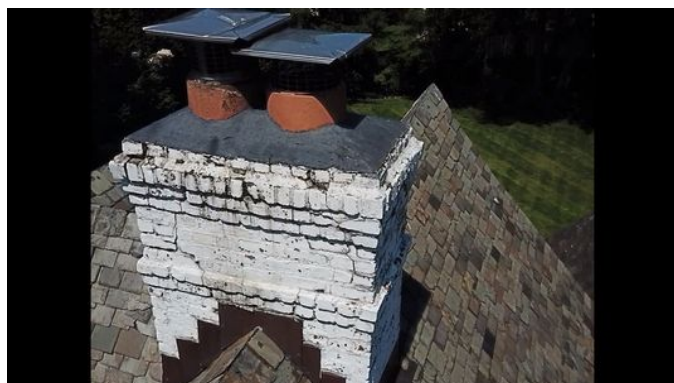
Comment 11

The masonry brick wall is in need of re-pointing (replacing the mortar between the bricks) to avoid water damage. Recommend hiring a qualified mason to repair or replace as necessary.

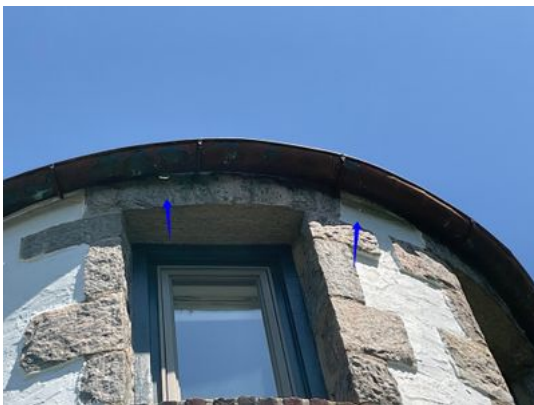
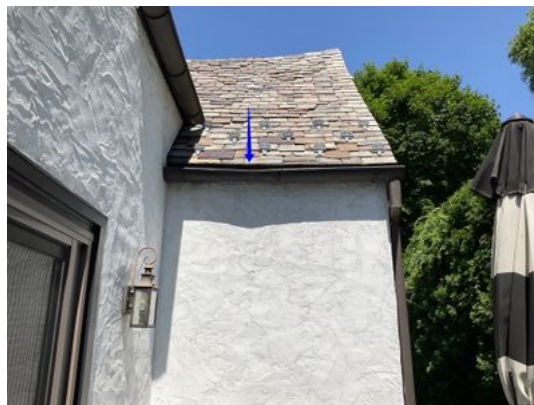
Comment 14
Repair

Damaged gutters should be repaired or replaced as necessary to avoid spilling roof runoff around the building - a potential source of water entry or water damage.

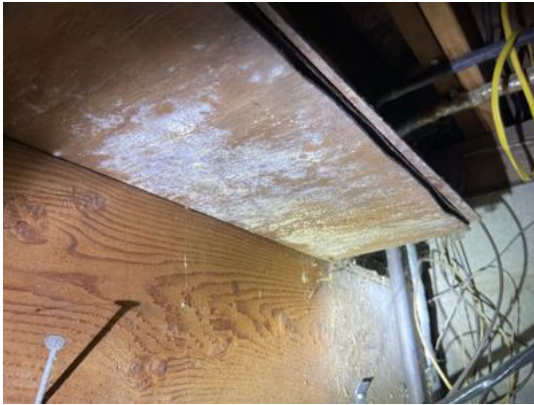
Comment 16

A mold like substance was observed on the underside of the flooring structure. Consult a licensed mold assessor for sampling and recommendations.

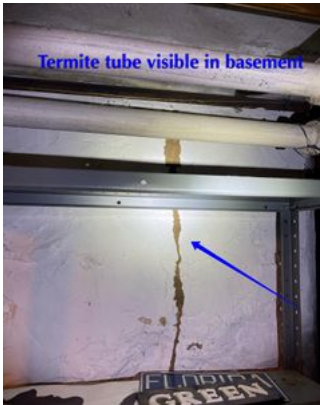
Comment 17

Evidence of wood destroying insect damage was observed and there is risk of additional hidden damage since termites can do a substantial amount of damage. If the property has not already been treated, a licensed pest control specialist should be engaged to eliminate further wood destroying insect activity within the home. Damaged wood should be repaired or replaced. Any wood soil contact should be eliminated.

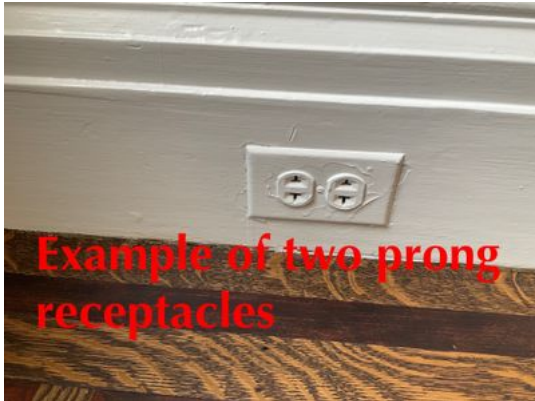
Comment 20

Older two prong outlets should be updated throughout the house.

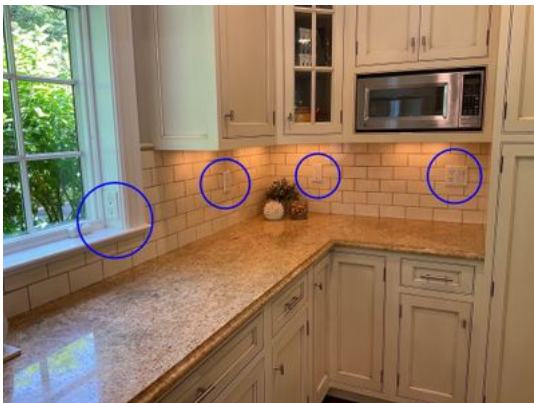
Comment 21

The ground fault circuit interrupter (GFCI) outlet did not respond correctly to testing during the inspection. This receptacle should be replaced.

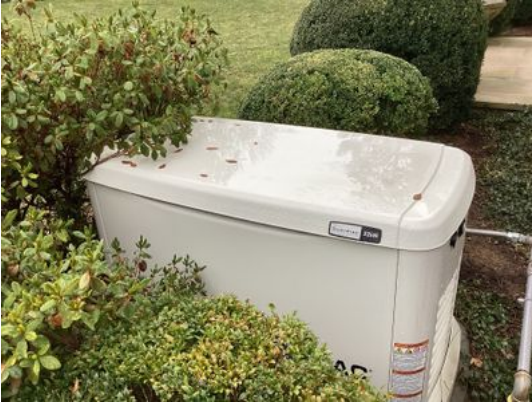
Comment 22
Information

A generator has been installed for the house. This is a specialized system that is beyond the scope of a home inspection. Consult with licensed electrician for details about condition, operation, and maintenance.

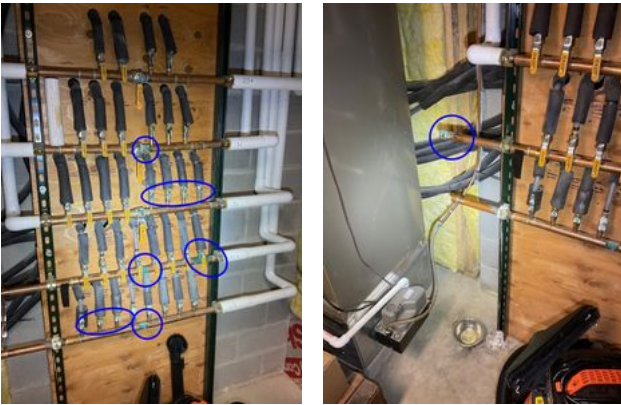
Corrosion on the exterior of the supply piping was observed.

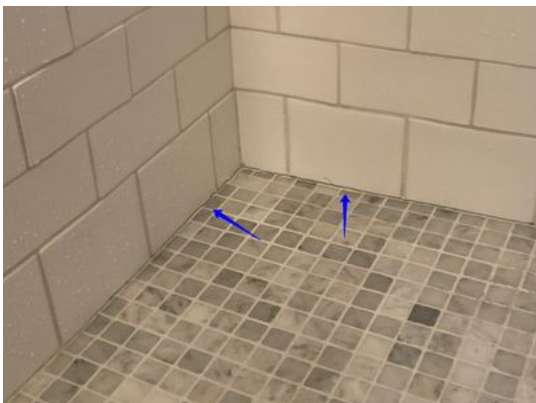
Comment 37
Repair

Shower Stall Tile caulk/grout repairs are needed.

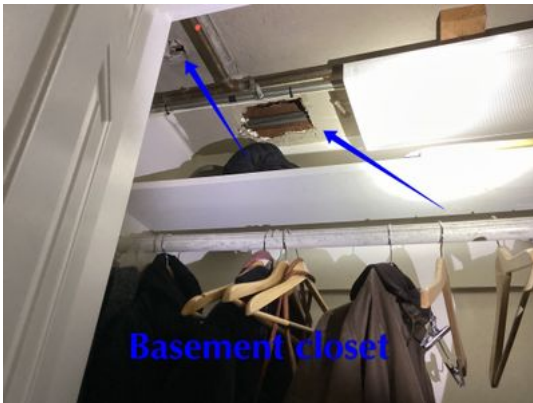
Damage to the interior finish was observed.

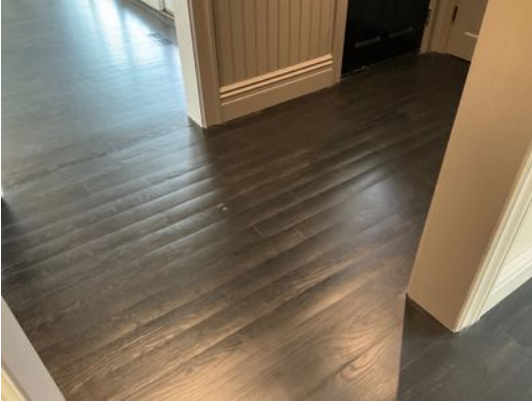
Comment 43
Major Concern

Evidence of warping to the hardwood flooring was noted.

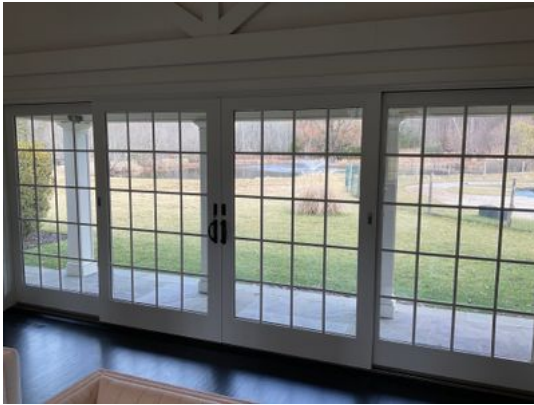
Thermo seals are broken at sliding door. Glass will be cloudy or droplets may form between panes. Replacing glass is only know way to repair.

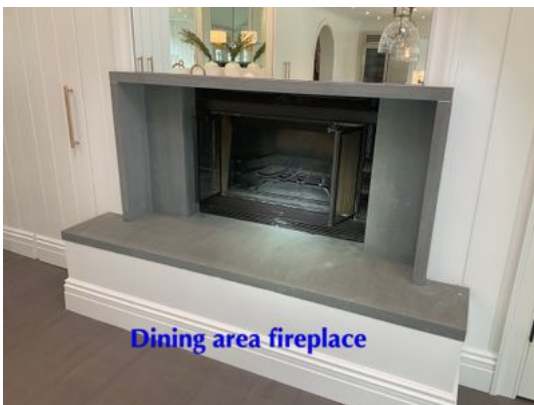
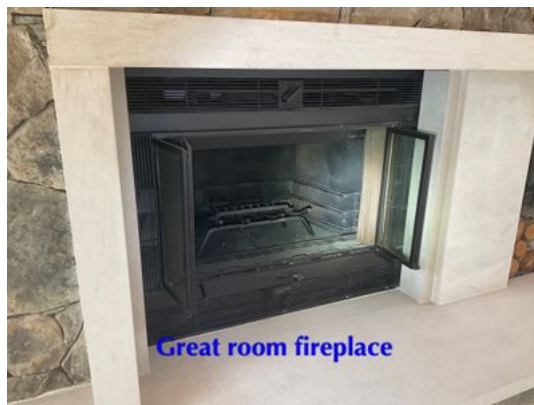
The fireplace chimney should be inspected and cleaned prior to operation.

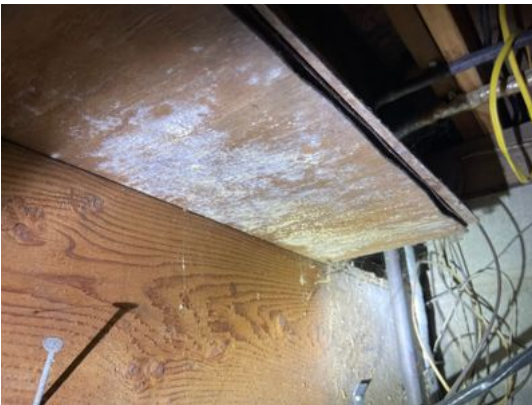
A mold like substance was observed on the underside of the flooring structure. Consult a licensed mold assessor for sampling and recommendations.

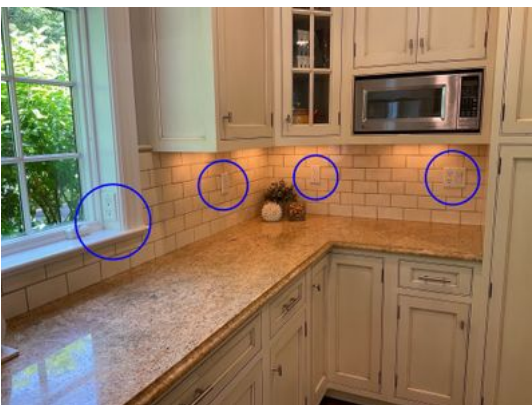
The ground fault circuit interrupter (GFCI) outlet did not respond correctly to testing during the inspection. This receptacle should be replaced.

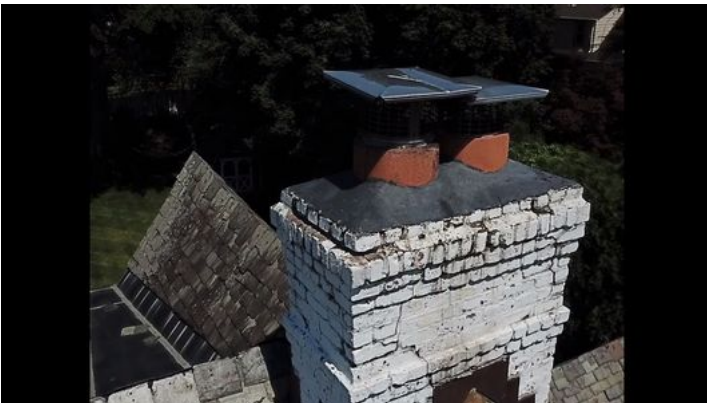
The crown of the chimney has been sealed with tar. Tar is flammable and should not be used for this application.

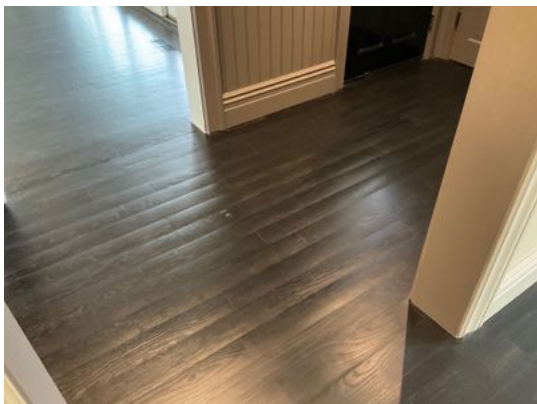
Evidence of warping to the hardwood flooring was noted.

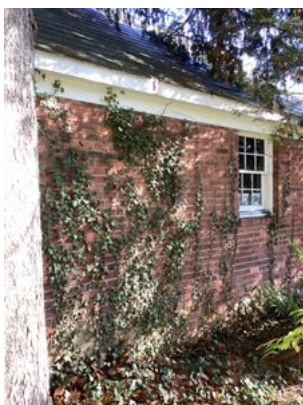
Vines growing on exterior walls should be kept trimmed away from siding, window trims, and the eaves to reduce risk of insect and water damage.

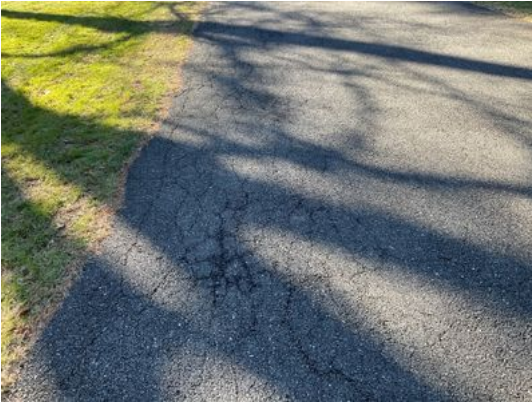
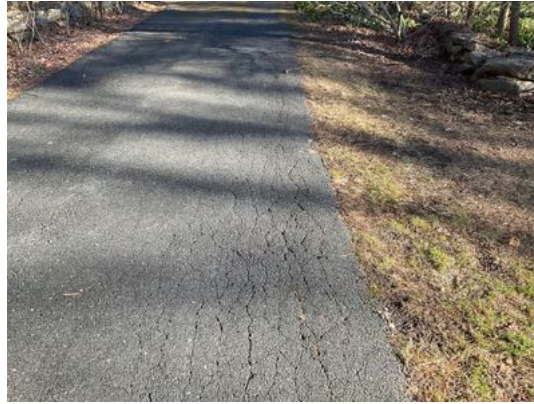
Cracking to the driveway surface was observed.

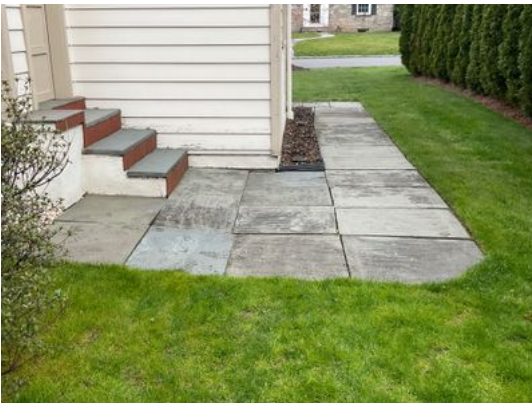
The walkway is in need of re-pointing repairs.

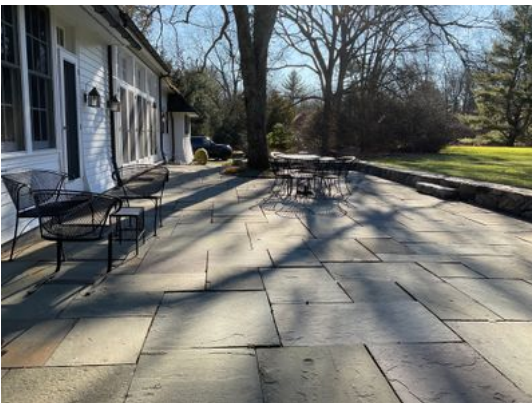
Evidence of heaving and settlement was observed to the stone patio. Leveling of the stones is needed.

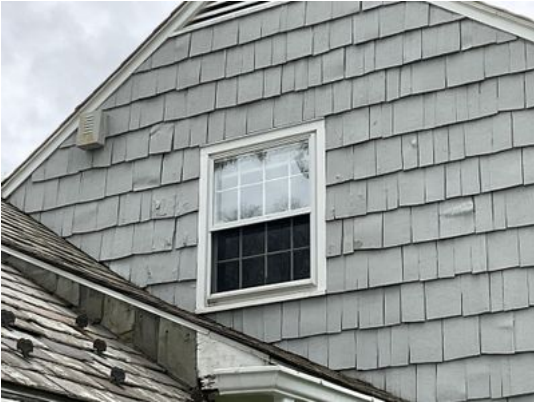
Peeling paint was observed at the siding.

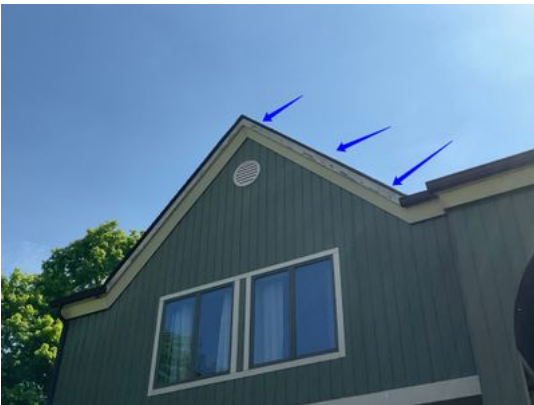
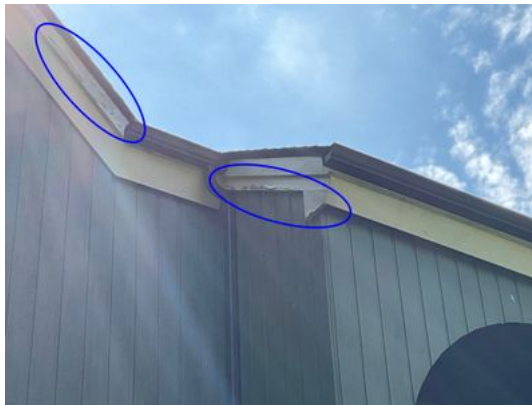
Soffit/Fascia/trim Painting Needed

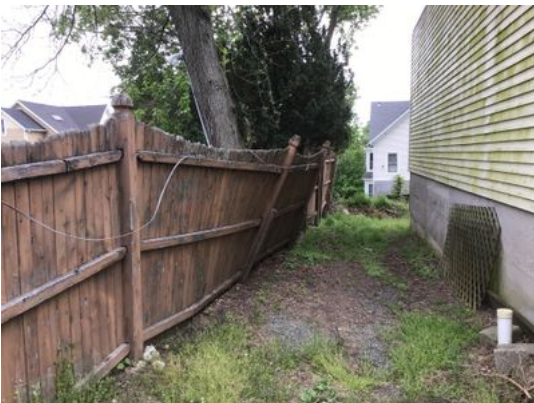
The fence is in Poor Condition and it requires repairs or replacement.

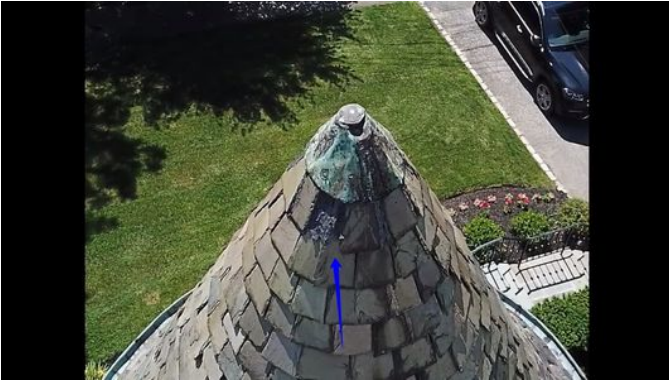
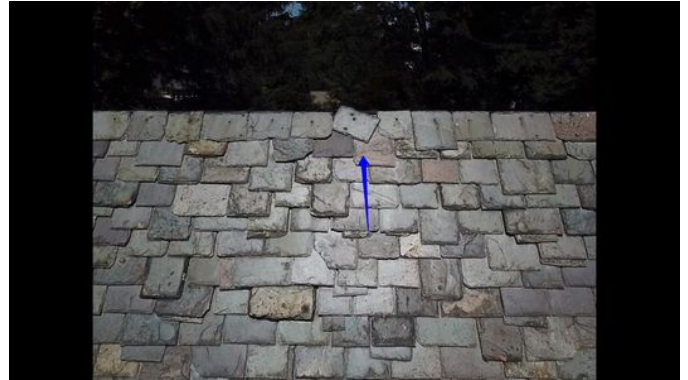
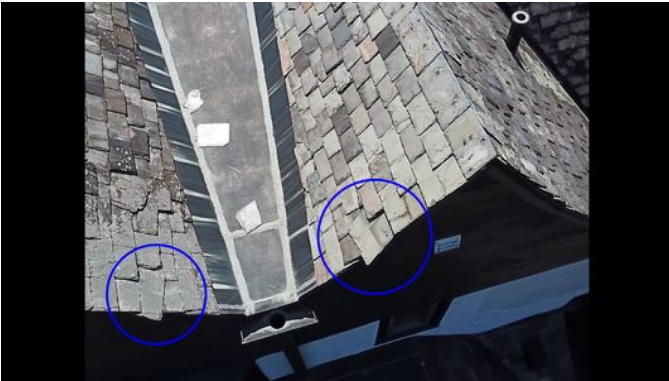
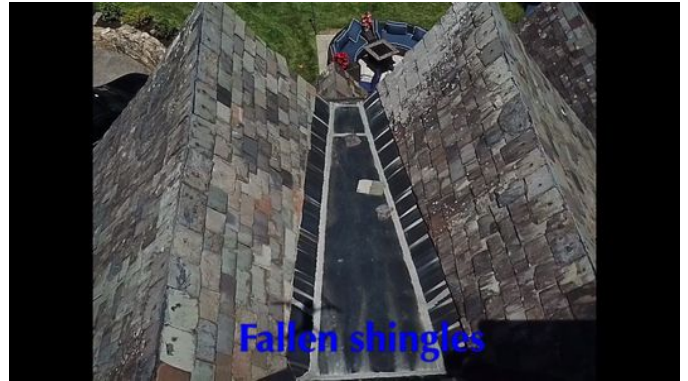
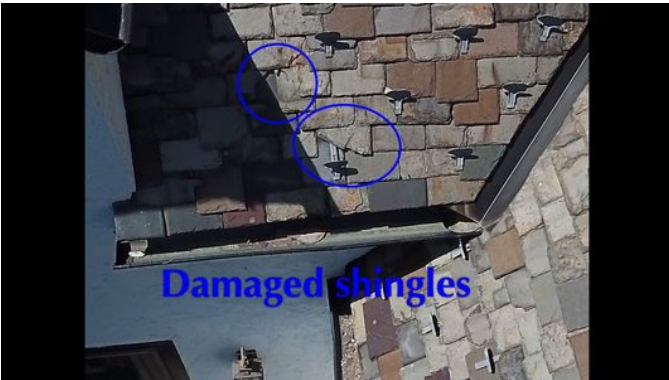
Repairs to the roofing are needed. Damaged or loose roofing materials should be repaired.

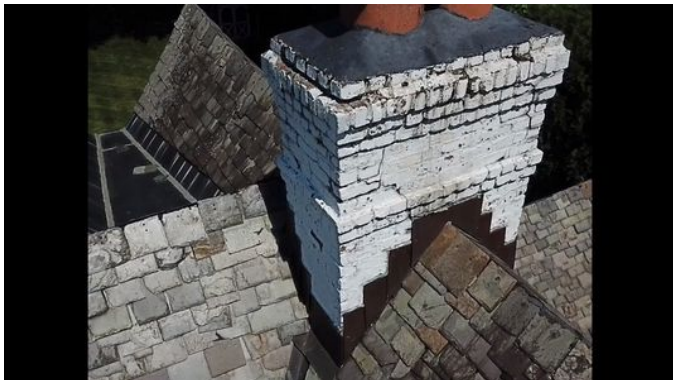
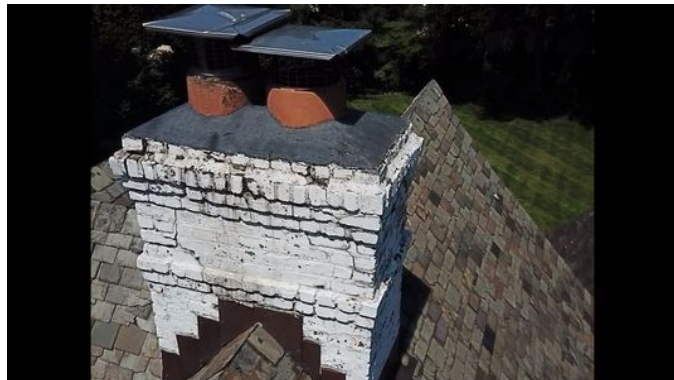
The masonry brick wall is in need of re-pointing (replacing the mortar between the bricks) to avoid water damage. Recommend hiring a qualified mason to repair or replace as necessary.

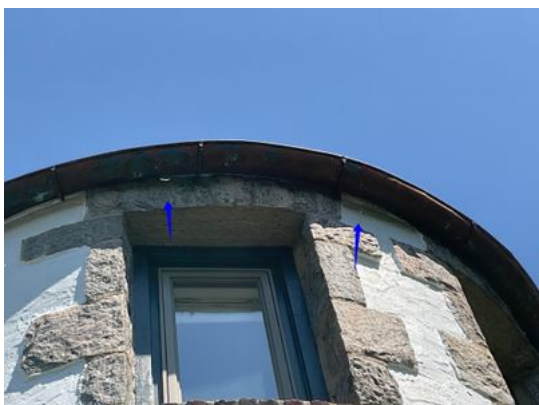
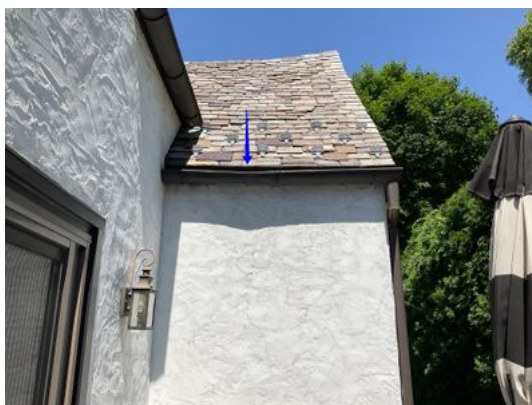
Damaged gutters should be repaired or replaced as necessary to avoid spilling roof runoff around the building - a potential source of water entry or water damage.

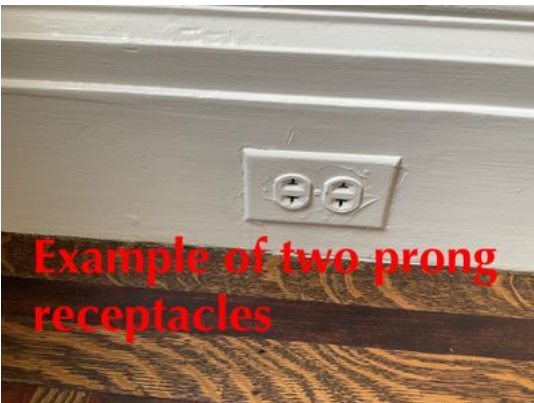
Older two prong outlets should be updated throughout the house.

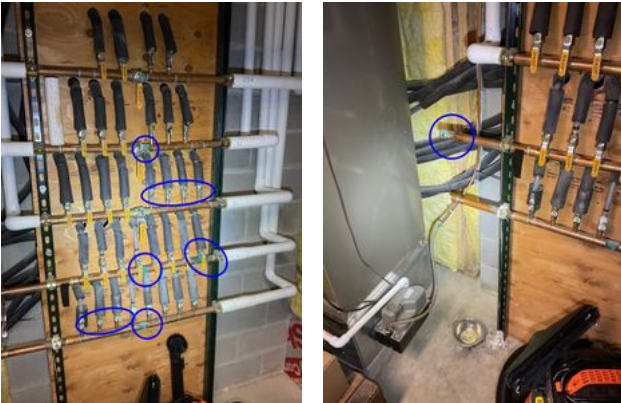
Corrosion on the exterior of the supply piping was observed.

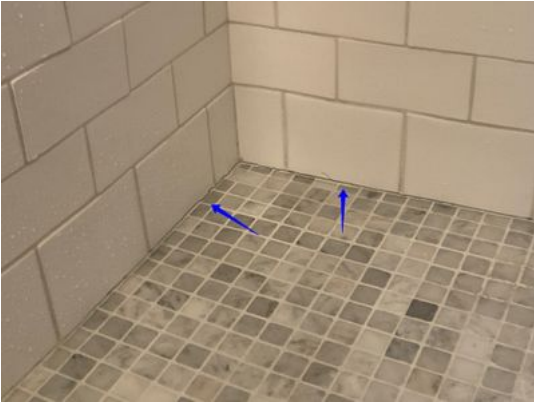
Shower Stall Tile caulk/grout repairs are needed.

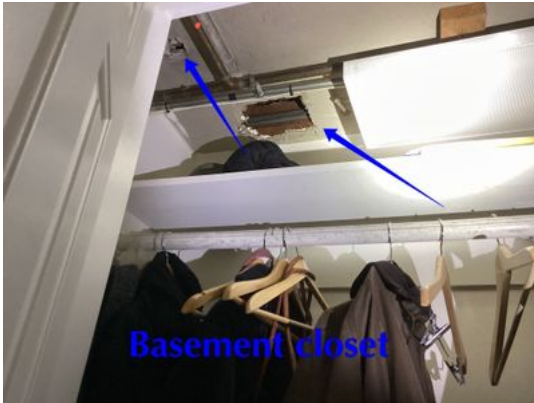
Damage to the interior finish was observed.

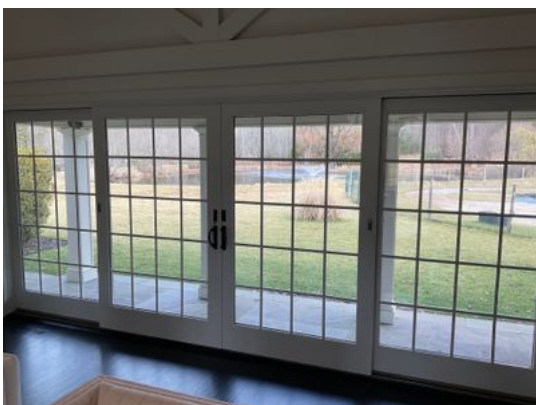
Thermo seals are broken at sliding door. Glass will be cloudy or droplets may form between panes. Replacing glass is only know way to repair.

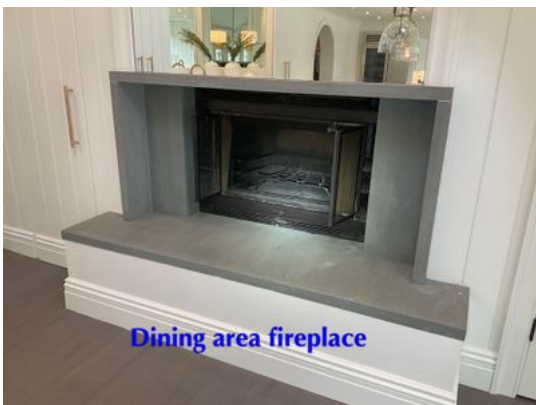
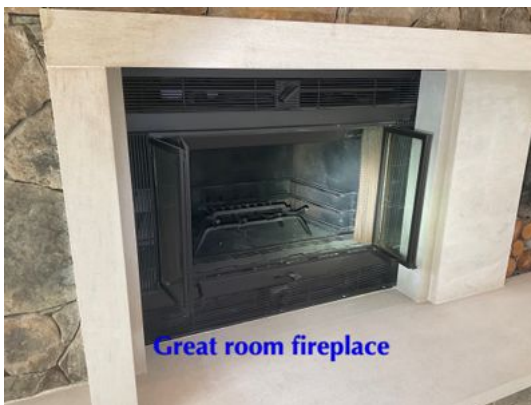
The fireplace chimney should be inspected and cleaned prior to operation.
