TrueView Home Inspections

Home Inspection Report

101 Main Street

Inspected On Tue, Jan 10, 2023 at 12:00 AM

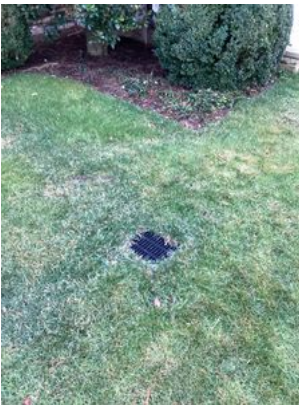
Keep exterior drains clear of debris.

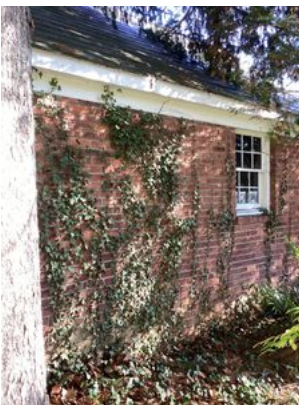
Vines growing on exterior walls should be kept trimmed away from siding, window trims, and the eaves to reduce risk of insect and water damage.

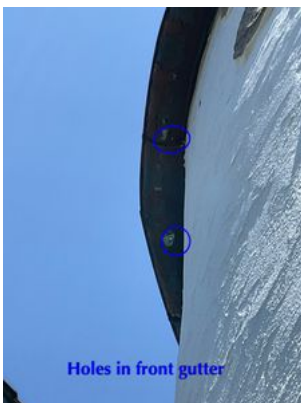
Comment 14
Repair

Damaged gutters should be repaired or replaced as necessary to avoid spilling roof runoff around the building - a potential source of water entry or water damage.

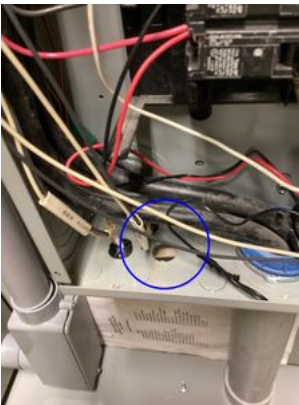
Any openings in the main panel should be covered.

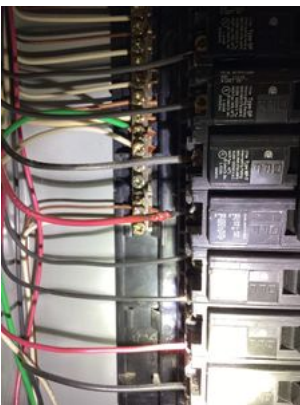
A scorched wire was observed in the sub panel. Consult a licensed electrician for repair.

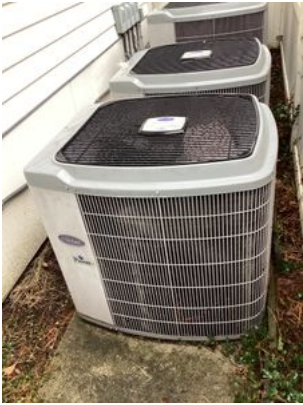
The air conditioning system is old. It may require a slightly higher level of maintenance, and may be more prone to major component breakdown. Predicting the frequency or time frame for repairs on any mechanical device is virtually impossible.

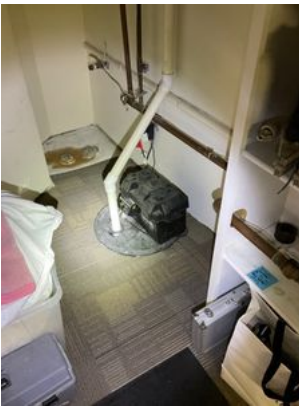
Sump pump float is not connected to switch. Will not operate as designed. Have repaired by licensed plumber.

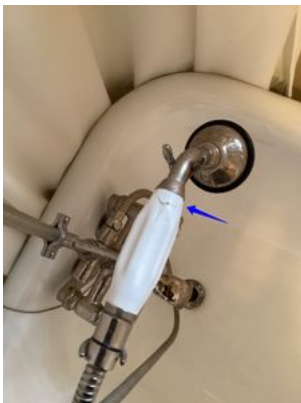
The handle at the shower head is damaged.

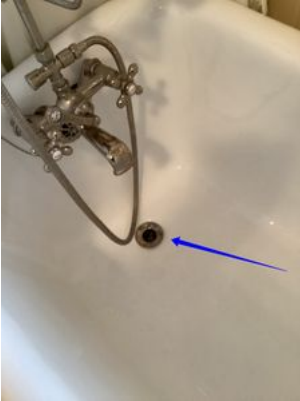
Comment 35

The drain stopper is missing in the bathtub.

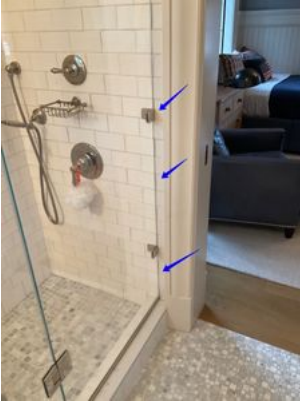
A leak was detected at the shower stall glass. Repair is needed.

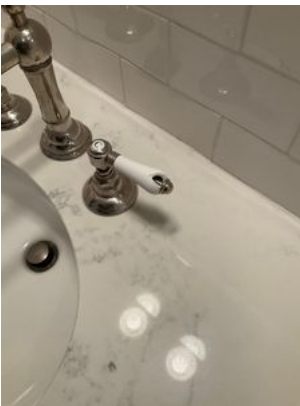
A faucet handle is damaged at the sink.

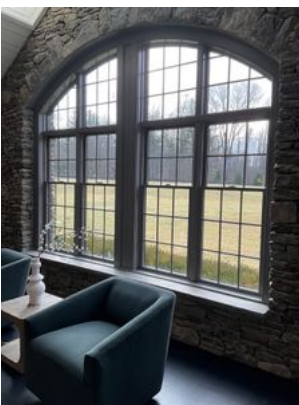
The window could not be opened. All windows should be operational.

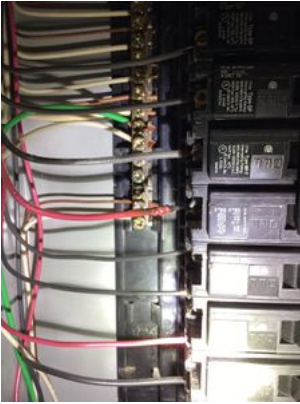
A scorched wire was observed in the sub panel. Consult a licensed electrician for repair.
